Influence of Geological Factors on Landslides: A Review of Several Landslides in Various Regions Of India

Abstract: Massive downslope movements of rock, detritus, or earth that constitute landslides are global occurrences that annually result in estimated 5,000 fatalities and extensive property damage. These phenomena arise from the complex interaction of human-induced and natural influences, and they manifest in a wide range of geoenvironmental conditions. Landslides predominantly transpire in the Himalayas of northern India and the Western Ghats of southern India within the country of India. Six landslide sites in the northern, northeastern, and southern regions of India were investigated in the field for the purposes of this article. At each of the locations, we offer explanations for the occurrence of multiple landslides. The objective of our research is to acquire a more comprehensive understanding of the precursors and causes of landslides. This knowledge will empower us to identify landslide-prone areas with greater precision and facilitate the timely detection of landslide incidents.

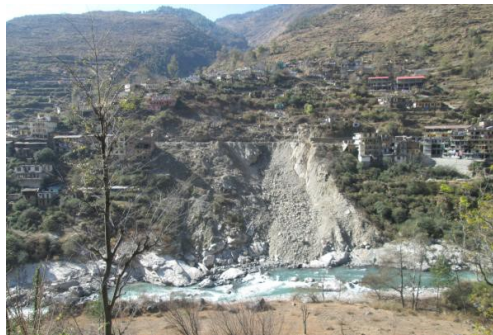
Similar to several neighboring hills, the Bhatwari hill/village ($30^{\circ}49'$ N, $78^{\circ}37'$ E, elevation 1610 m, figure 2) is situated along the banks of the River Bhagirathi, one of the two headstreams of the Ganges, in Uttarkashi Town. National Highway 108 traverses the aforementioned peaks. Numerous landslides have occurred in Bhatwari and the surrounding highlands of Uttarakashi, specifically apprehensively during the monsoon season [5].

Uttarakashi is situated in a seismically active zone and is bounded by two main thrust faults: the Main Central Thrust (MCT) and the Srinagar Thrust. The metamorphosed Central Crystallines (schists, gneisses, amphibolites, migmatites) that protrude southward over the less metamorphosed Garhwal Group (quartzites, epidiorites, slates) constitute the MCT. Fluvio-glacial material is present as a loose, unconsolidated overburden on Bhatwari Hill, which is composed of foliated mica schist sandwiched between massive jointed gneissic rocks.

Since 2009, subsidence has been documented [5]. A landslide induced by precipitation transpired from the evening of August 12th to the 13th, 2010, and an additional slide transpired on June 16th, 2013 amidst the Uttarakhand floods of 2013 [5]. Erosion of the hill's toe by the Bhagirathi, saturation of the loosely-consolidated overburden, the steep slope of the hill, the presence of thin mica schist foliations between the jointed gneissic rocks, and water leading to the removal of fines at the overburden-rock interface were all contributory factors to these landslides.

Figure 2. Bhatwari Landslide

The implications of our results regarding the Bhatwari collapse (section 3) extend to other landslide incidents in the surrounding area. Upon observing the adjacent slides, we observed that all of the hills are situated along the Bhagirathi River, possess comparable geological characteristics and slope angle to Bhatwari Hill, and landslides occurred on June 16, 2013, just as they did on that date. There is an assumption that, similar to the landslides on Bhatwari Hill, these also resulted from the combined effects of excessive rainfall and toe erosion induced by the Bhagirathi River over loosely compacted detritus.

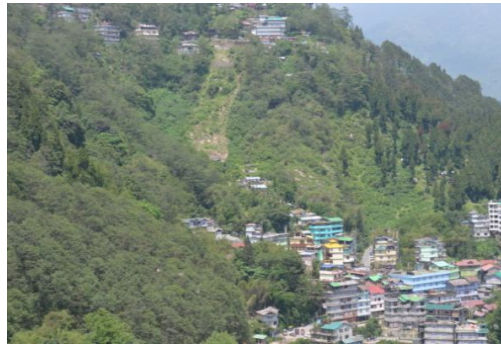
Figure 3 illustrates the location of Chandmari Hill ($27^{\circ}20'$ N, $88^{\circ}33'$ E, 1459 m elevation) within the Eastern Himalayan mountain ranges of Gangtok, the capital of Sikkim State. The Daling Group, which consists of dolomites, phyllites, and quartzites, is frequently encountered, in addition to streaky foliated augen gneisses like the Lingtse Gneiss [6]. Additionally, bands composed of weathered

biotite-muscovite schist are often observed. A substantial accumulation of soil overburden coexists with weathered mica gneiss and boulders. Prevalent minerals in the area consist of quartz, feldspar, and mica.

In 1966, subsidence was initially documented [7]. Following its relatively active phase from 1975 to 1976, the landslide exhibited a period of relative stability until its reactivation as a landslide and subsidence zone in June 1984 [8]. On the night of June 8-9, 1997, a precipitation of 211 millimeters in four hours caused at least nine landslides in the vicinity of Gangtok, one of which occurred in Chandmari. Landslides instigated by precipitation transpired in July 2007 and June 2011, whereas minor debris slides were instigated by an earthquake that struck the Sikkim-Nepal border on September 18, 2011. At the moment, a downward trend is being detected in this location. Landslide occurrences can be attributed to various factors, including but not limited to heavy precipitation, the existence of weathered rocks, the contrast in permeability between adjacent soil strata, seismic activity, and anthropogenic influences like improper construction practices.

Figure 3. Chandmari Landslide

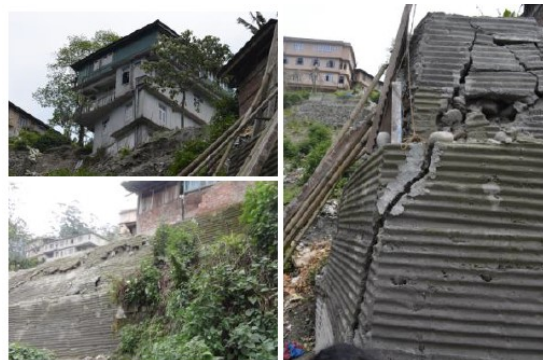
District headquarters for North Sikkim are located in Mangan. The local marketplace, Old Mangan Bazaar ($27^{\circ}30' N$, $88^{\circ}32' E$, 1137 m elevation, figure 4), has previously been affected by landslides [9]. Three rock varieties predominate in Mangan: biotite schist, quartz-biotite schist, and garnetiferous mica schist. Due to their characteristic foliation, schists are susceptible to erosion. Approximately one kilometer from this location, the Teesta River erodes the hill's base, causing additional instability. The most recent deluge transpired on September 20, 2012, subsequent to a precipitation of 196.6 mm. Extreme precipitation from September 19–23, 2012, precipitated numerous additional landslides in the area. RaffongKhola, a tributary of the River Teesta, exacerbated erosion, which reactivated previous landslides.

Figure 4. Mangan Landslide

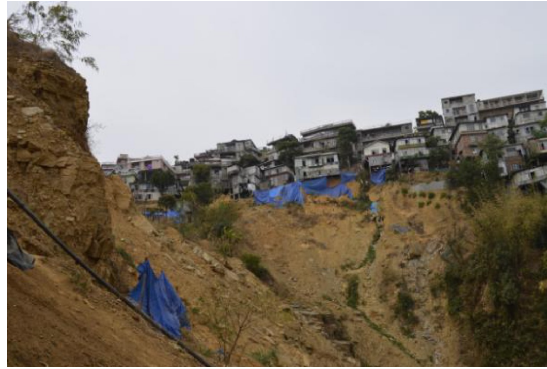
Aizawl, the administrative center of the state of Mizoram, is situated at an average elevation of 1132 meters on a narrow, elongated, north-south trending anticlinal ridge. Ramhlun Sports Complex, situated at an elevation of 963 m ($23^{\circ}45' N$, $92^{\circ}43' E$) and bounded to the east by an escarpment and the north by Bangla Lui, a tributary stream of the Chite Lui River, is a densely populated area in Aizawl City (figure 5).

In Mizoram, only sedimentary minerals are present. A narrow bed of fine-grained silty shale underlies a relatively thick bed of silty sandstone/siltstone, which is followed by well-bedded sandstone, constitutes the

rock formation at Ramhlun Sports Complex. A number of joint pairs and fractures are discernible within the granite substrate. The overburden is comprised of fragments of porous shale embedded in powdery soil.

Since 1994, creep movement has been documented. Debris collapses and rock falls triggered by precipitation transpired on the 19th of July, 2004; the 14th of September, 2007; and the 10th and 20th of August, 2012. More recently, in August 2013, land subsidence caused the collapse of several homes. Joints, fractures, and fissures within the granite substrate are pivotal contributors to the slope's instability. Additional elements that contribute to slope instability comprise the sharp eastward escarpment, conspicuous bedding planes within the bedded sandstone, substantial precipitation, erosion caused by Bangla Lui Stream, and an inadequate drainage system that permits water infiltration through joints and fissures, resulting in overburden material saturation.

Figure 5. Landslide at Ramhlun Sports Complex

It is advisable to exercise caution when extrapolating findings. Laipuitlang (section 7) and Ramhlun (section 6) both have comparable geological characteristics in Aizawl; however, anthropogenic factors were the

primary cause of the slides at Laipuitlang, whereas geological factors were the predominant contributors to the Ramhlun slides.

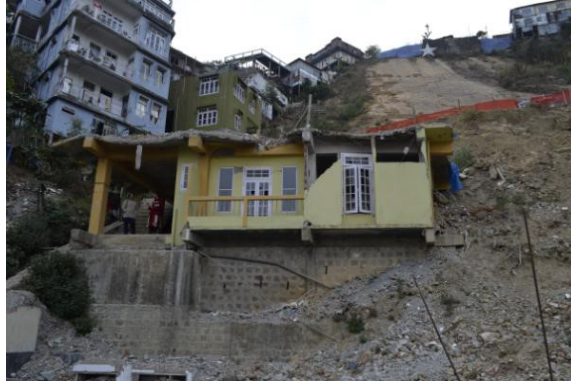
Figure 6 illustrates Laipuitlang Hill (23°44' N, 92°43' E, 1134 m elevation) as an additional densely populated area within Aizawl City. Substratum bedded sandstone is composed of shale, whereas the overburden is comprised of granular soil that is fragmented with shale. Joints can be observed within the granite substrate.

The region was formerly a sandstone quarry; the slope was destabilized by the quarrying, which caused rockslides in 1957 and 1968. Quarrying ceased at that time. The hill experienced additional rockslides on 5 May 2002 and 25 November 2007 as a result of careless excavation. [10], [11] The next indication of landslide activity was the development of fissures in a five-story structure in 2010. Cracks began to manifest in September 2012 along the walls and limestone base of a sizable Public Works Department (PWD) structure perched atop the hill. Placing the building at the interface of shale and sandstone was essential.

Geologists from the Directorate of Geology and Mineral Resources, Government of Mizoram, firmly advised the building's demolition for reasons of safety; however, no prompt action was taken. Due to inadequate drainage, precipitation infiltrated the substructure of the PWD structure, exacerbating its structural vulnerability. After a week of intense rainfall, the structure and its foundation fell downhill between 2:30 and 3:00 am on 11 May 2013, submerging ten dwellings and a church. On the left flank, the uppermost sandstone stratum was virtually entirely eroded, with only a few remnants remaining. [10], [11].

The Laipuitlang landslides were significantly and visibly influenced by anthropogenic factors, including quarrying, indiscriminate excavation of the hill, and the construction of the enormous PWD building on the sandstone-shale interface. Additional contributing factors comprise the existence of vertical joints, substantial precipitation, inadequate drainage, and water infiltration through bedded intersections and rock joints. Shale is a potentially problematic material; the occurrence of the 2013 landslide was significantly influenced by the deterioration and subsequent shifting of the shale foundation, which was precipitated by water.

Figure 6. Laipuitlang Landslide

Landslides may be triggered exclusively by natural factors, as exemplified by the Anthoniar Colony slide of 1926, or by a confluence of natural and anthropogenic influences, as demonstrated by the Laipuitlang slides.

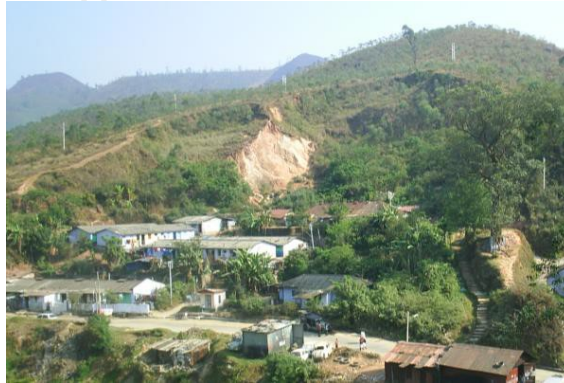
Figure 7 illustrates the location of Anthoniar Colony (48°08' N, 11°31' E, 1520 m elevation) in the Kerala State tourist town of Munnar. The primary rock types at Munnar are Precambrian crystallines, which include hornblende-biotite gneiss, biotite gneiss, granite gneiss, charnockite, and pink granites [12]. Granite gneiss forms the bedrock at Anthoniar Colony, which is covered by a substantial overburden of lateritic soil. Kaolinite and illite are the predominant minerals, with quartz sericite patterns also being observed. There are fissures visible on the hill [4].

Two slide events have taken place in Anthoniar Colony. The initial one that occurred in 1926 was plausibly the result of precipitation and poor geological conditions, as the area was devoid of inhabitants at the time. More recently, on July 25, 2005, a torrential deluge of 451 mm caused landslides in this location as well as two other locations in Munnar. The slope was further intensified as a result of anthropogenic activities, including the excavation of the hill [4].

Figure 7. Anthoniar Colony Landslide
